**HYDRAULIC MODEL
INVESTIGATION**

TECHNICAL REPORT NO. 104-1

**Spillway Deflectors at Bonneville, John Day and McNary
Dams on Columbia River, Oregon-Washington and
Ice Harbor, Lower Monumental and Little Goose Dams
on Snake River, Washington**

**CONDUCTED BY
DIVISION HYDRAULIC LABORATORY
U. S. ARMY CORPS OF ENGINEERS
NORTH PACIFIC DIVISION
BONNEVILLE, OREGON**

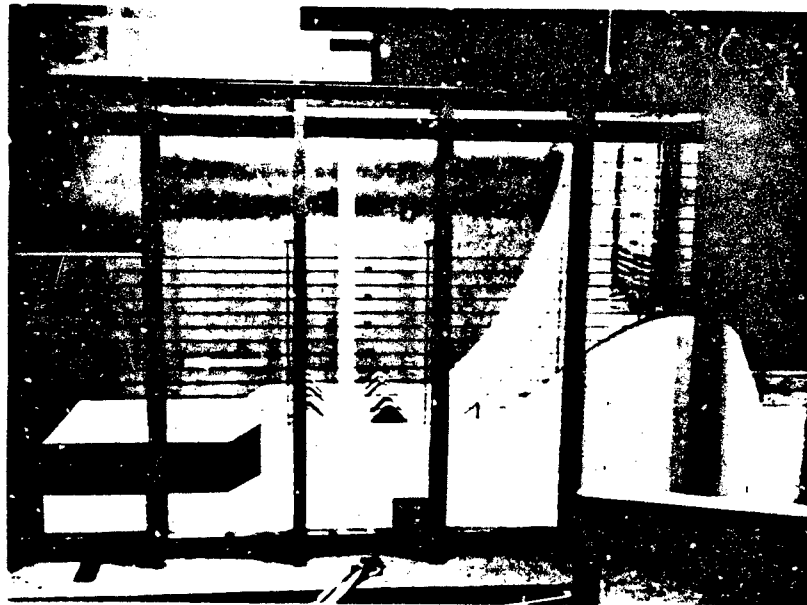
Bonneville Dam.

Photograph 1. Dry bed of 1:25-scale model showing existing spillway.

8. The 1:25-scale model simulating one bay of the existing spillway and the stilling basin is shown on photograph 1. A separate comprehensive model (primarily constructed for the Bonneville second powerhouse study which ultimately was constructed in 1982) at a scale of 1:100 was used to evaluate the overall performance of the deflectors (photograph 2).

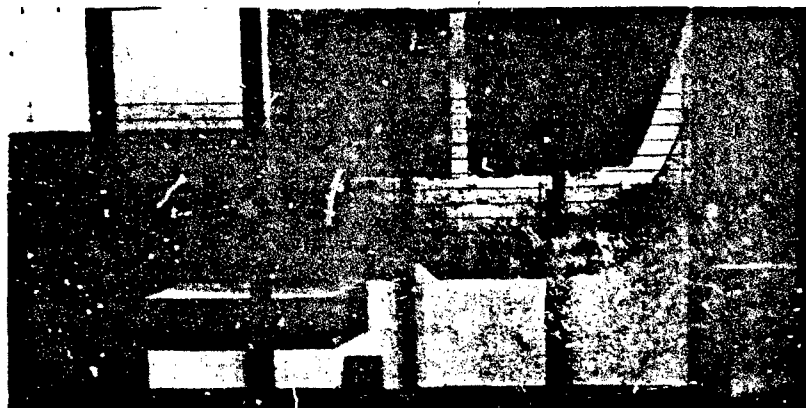
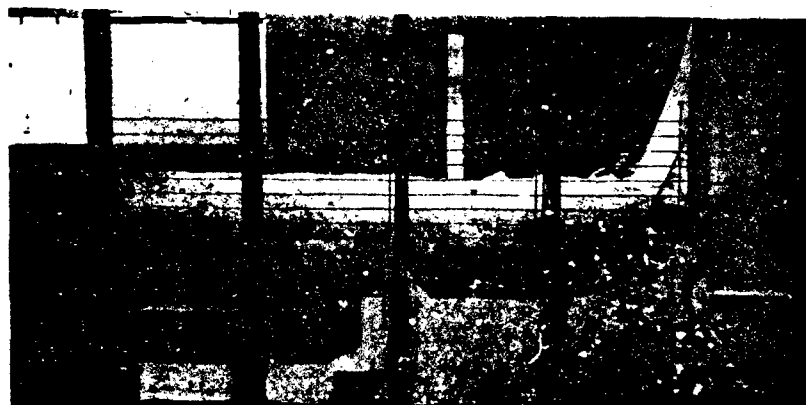
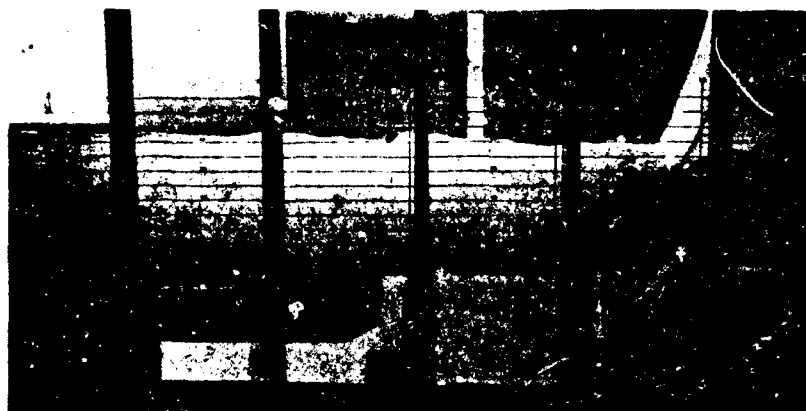
River discharge 220,000 cfs (4,700 cfs per bay).
Plunging flow, tailwater elevation 20.1.

River discharge 300,000 cfs (9,750 cfs per bay).
Plunging flow, tailwater elevation 25.4.

River discharge 400,000 cfs (16,000 cfs per bay).
Plunging flow, tailwater elevation 31.2

Photograph 3. Existing prototype conditions with normal tailwater. Pool elevation 74.0, powerhouse discharge 140,000 cfs.

Combined discharges of 220,000, 300,000, and 400,000 cfs were selected for the initial tests which simulated discharges of 4,700, 9,750, and 16,000 cfs per bay, respectively, with 16 of 18 spillway bays in operation. With the existing spillway, flow with all three discharges followed the concrete outline of the ogee and plunged to the bottom of the stilling basin. Profile views indicating zones of aeration and flow directions with these discharges are shown in photograph 3 and on plate 2.

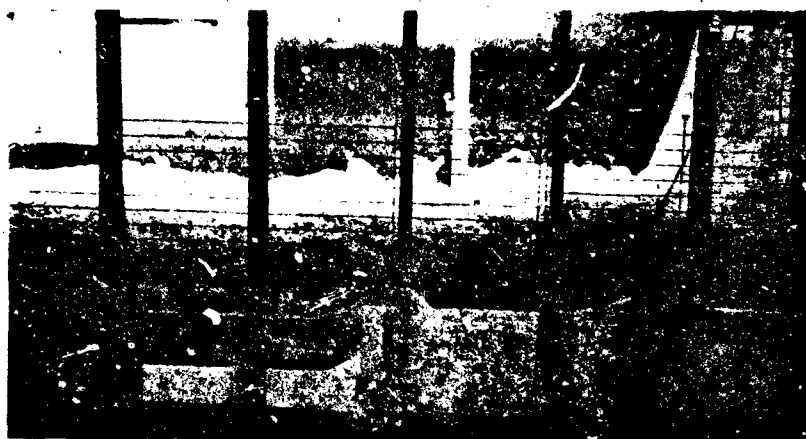
River discharge 220,000 cfs (4,700 cfs per bay).
Skimming flow, tailwater elevation 20.1.

River discharge 300,000 cfs (9,750 cfs per bay).
Skimming flow, tailwater elevation 25.4.

River discharge 400,000 cfs (16,000 cfs per bay).
Skimming flow, tailwater elevation 31.2.

Photograph 5. 6-foot deflector at elevation 12 with normal tailwater. Pool elevation 74.0, powerhouse discharge 140,000 cfs.

10. Initially, a 6-foot-long deflector connected to the ogee upstream by a 6-foot-radius fillet was studied at elevation 12 (photograph 4 and on plate 3). Observations of zones of aeration and flow directions for the three test flows are shown in photograph 5 and on plate 4. Standing waves developed on the water surface, with the largest one located between the deflector and first row of baffles. Lowering the tailwater elevation (to decrease the submergence of the deflector) reduced the waves and therefore indicated the deflector was too low.

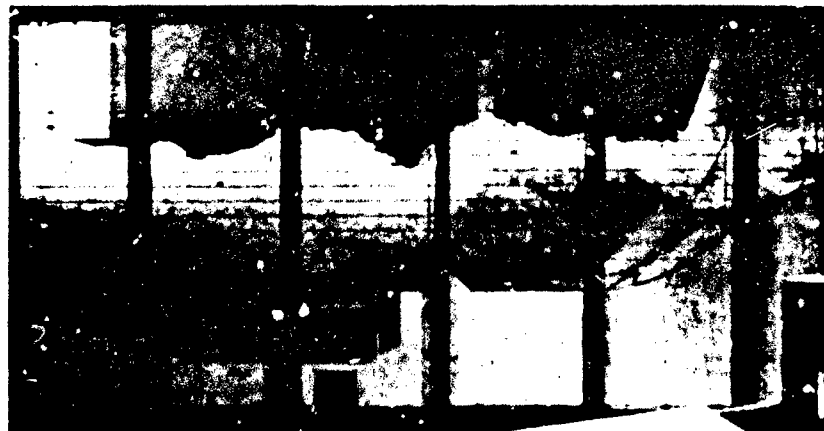
River discharge 220,000 cfs (4,700 cfs per bay).
Skimming flow, tailwater elevation 20.1.

River discharge 300,000 cfs (9,750 cfs per bay).
Skimming flow, tailwater elevation 25.4.

River discharge 400,000 cfs (16,000 cfs per bay).
Skimming flow, tailwater elevation 31.2.

Photograph 6. 12-foot deflector at elevation 12 with normal tailwater. Pool elevation 74.0, powerhouse discharge 140,000 cfs.

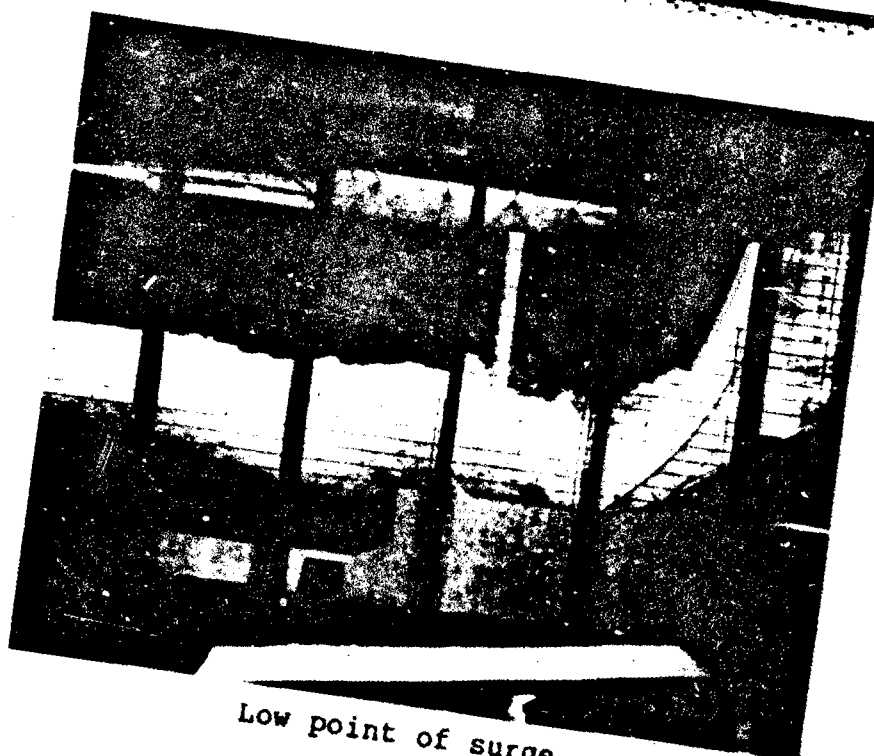
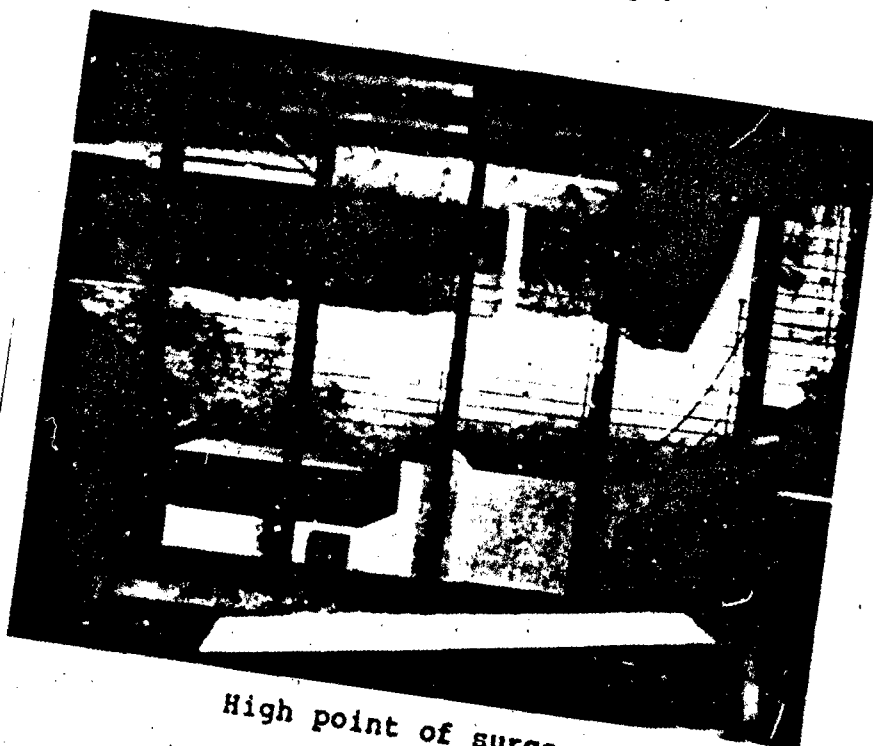
Low point of surge.

High point of surge.

Photograph 9. Unstable flow with 12-foot deflector at elevation 17 with normal tailwater elevation 25.4. River discharge 300,000 cfs (16,000 cfs per bay), pool elevation 74.0.

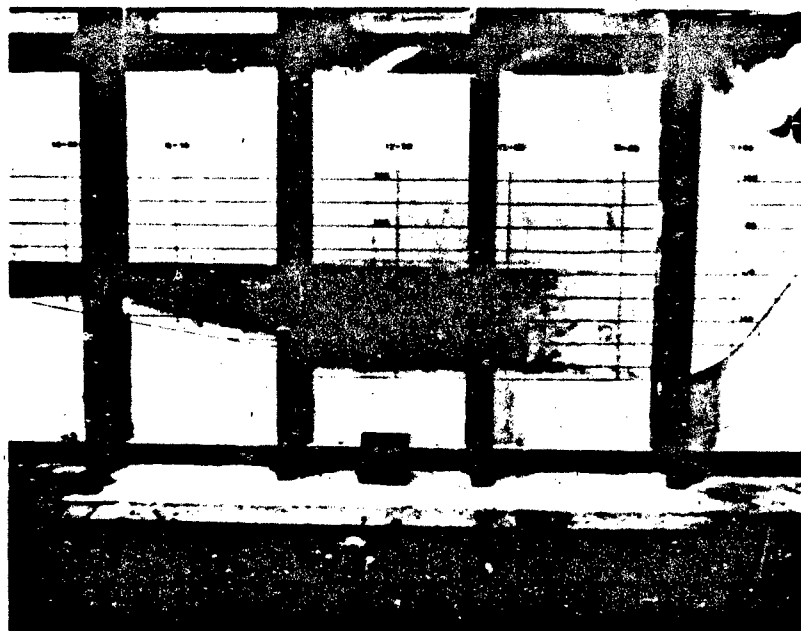
Spillway discharge 3,000 cfs per bay.
9 powerhouse units in operation.

Spillway discharge 7,200 cfs per bay.
5 powerhouse units in operation.

Photograph 17. Flow conditions with existing spillway and
stilling basin (no deflectors). River
discharge 250,000 cfs. Pool elevation 265;
tailwater elevation 163.0.

17. Initial tests were conducted with downstream channel topography at elevation 145 to observe flow conditions and air entrainment under existing conditions with varying operating conditions (photographs 17 and 18, and plate 15). With all flows, the nappe, heavily entrained with air, was carried to the bottom of the stilling basin and resulted in mixing throughout the full depth of the basin.

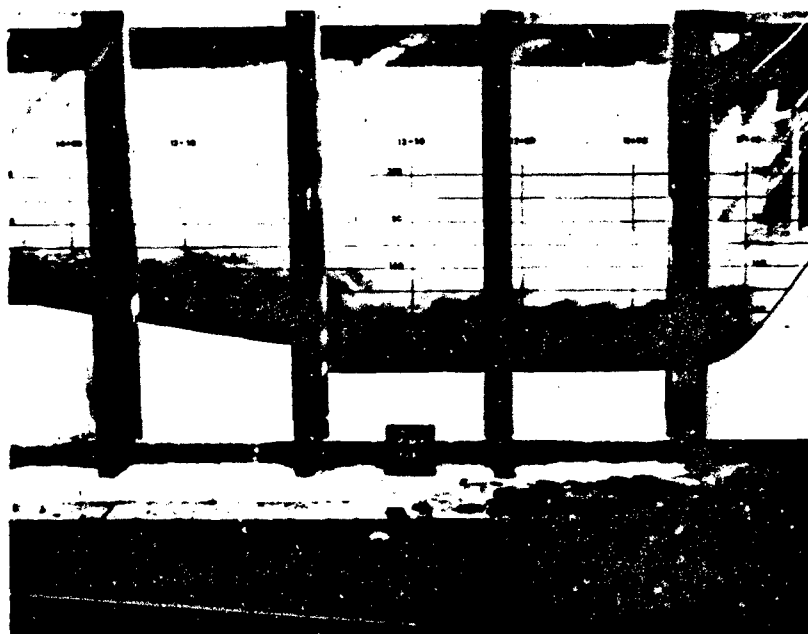
Photograph 18. Flow conditions with existing spillway and stilling basin (no deflectors). Spillway discharge 112,500 cfs per bay. River discharge 2,250,000 cfs. Pool elevation 277.9; tailwater elevation 201.0. No powerhouse units in operation.

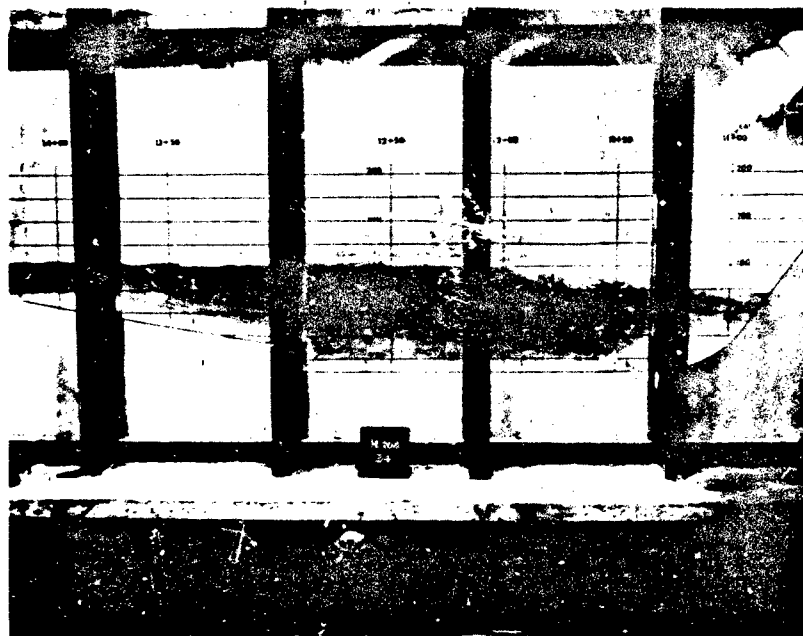
Photograph 19. Flow conditions with 12.5-foot deflectors at elevation 149. Spillway discharge 3,000 cfs per bay. River discharge 250,000 cfs. Pool elevation 265; tailwater elevation 163.0. 9 powerhouse units in operation.

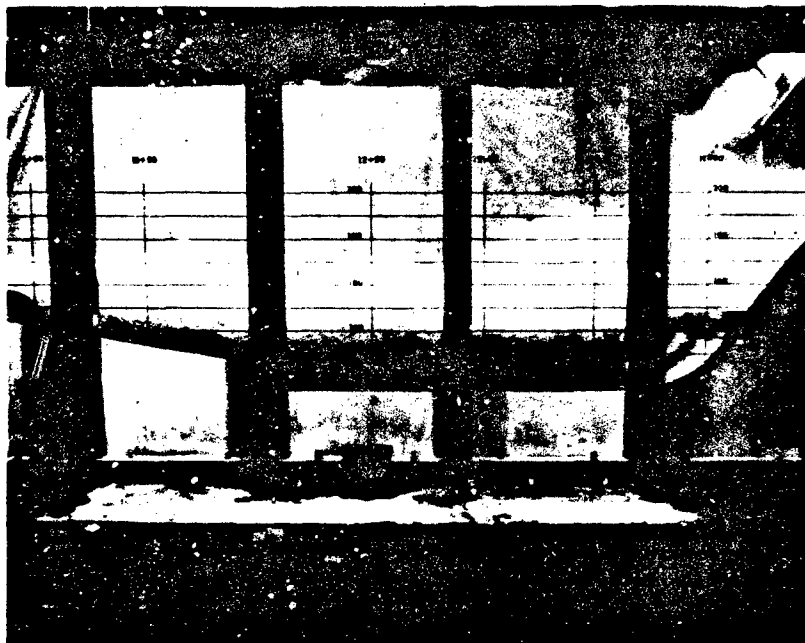
Photograph 22. Flow conditions with 12.5-foot deflectors at elevation 149. Spillway discharge 16,500 cfs per bay. River discharge 440,000 cfs. Pool elevation 265; tailwater elevation 167.4. 5 powerhouse units in operation.

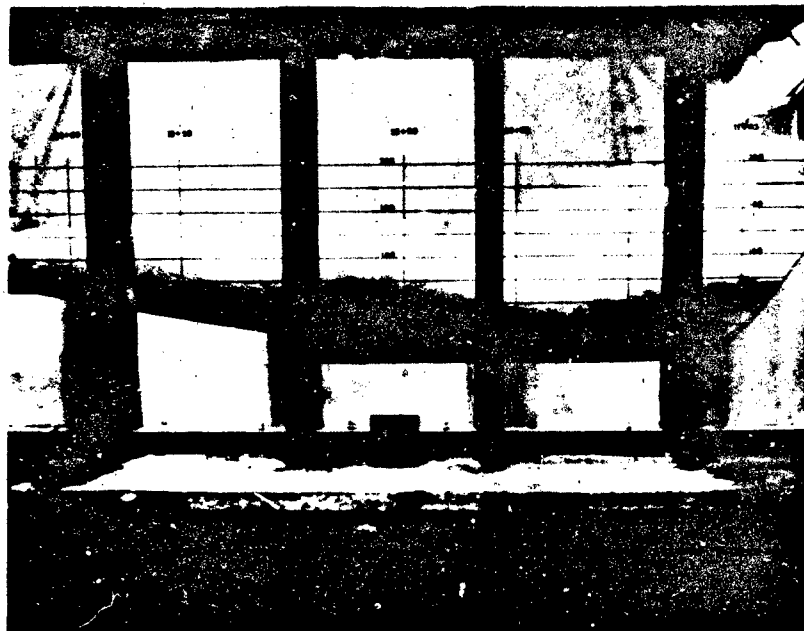
Photograph 23. Flow conditions with 12.5-foot deflectors at elevation 149. Spillway discharge 19,300 cfs per bay. River discharge 500,000 cfs. Pool elevation 265; tailwater elevation 168.8. 5 powerhouse units in operation.

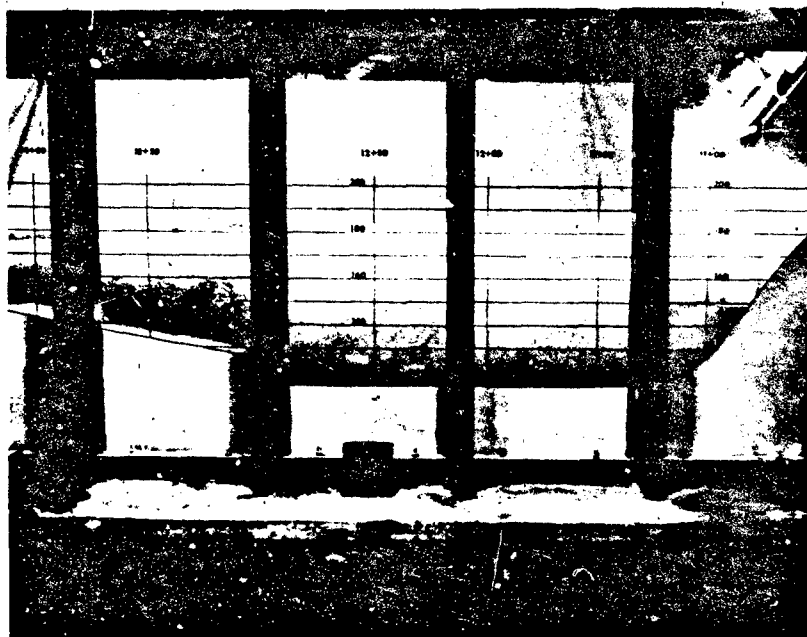
Photograph 24. Flow conditions with 12.5-foot deflectors at elevation 149. Spillway discharge 33,900 cfs per bay. River discharge 800,000 cfs. Pool elevation 265; tailwater elevation 176.7. 5 powerhouse units in operation.

18. After comparing the flow performance of different length deflectors (plate 16), the 12.5-foot-long deflector was recommended and chosen for the optimum design. A factor in selecting the optimum location of the 12.5-foot-long deflectors was flow stability in the stilling basin. Plate 17 shows discharge and tailwater relationships for both stable and unstable flow conditions occurring with the four lip elevations tested. With the deflectors at elevation 149, stable skimming flow occurred with discharges up to approximately 16,000 cfs per bay with 5 powerhouse units in operation (minimum nighttime load). Tailwater limits are shown for powerhouse operation varying between 5 and 16 units with The Dalles pool at elevation 160. Plate 17 also shows discharge and tailwater relationships for the skimming nappe uplifted by excessive depth on the deflector lip. The uplift resulted in a diving flow downstream and tended to increase the depth of air penetration in the basin. Uplift was less of a problem at lower discharges and tailwater depths. Although spillway discharges for 16-unit powerhouse operation (maximum daytime load) fell within the excessive uplift area, the deterioration from good skimming flow conditions was borderline but not considered serious. This condition would improve with The Dalles pool at less than elevation 160. Tests were conducted to determine an elevation of the deflector lip which would provide the best performance in the stilling basin for discharges equivalent to the 10-year-frequency flood. Several combinations of deflector elevations and discharges were used. Only minor changes occurred in degree, concentration, and depth of air penetration by varying the deflector elevations. Regardless of location, the area susceptible to the draw-down effect of aerated flow was in the vicinity of the stilling basin end sill where velocities in the deep return flow were generally high enough to pull surface aeration downward. With the downstream topography set at elevation 145, the optimum deflector elevation was 149 since the least amount of air was entrained with the lower discharges and the best energy dissipation occurred within the stilling basin with higher discharges (photographs 19 through 25 and plates 18 and 19). Energy dissipation (photographs 24 and 25) was satisfactory with the standard project flood (33,900 cfs per bay) and the maximum design

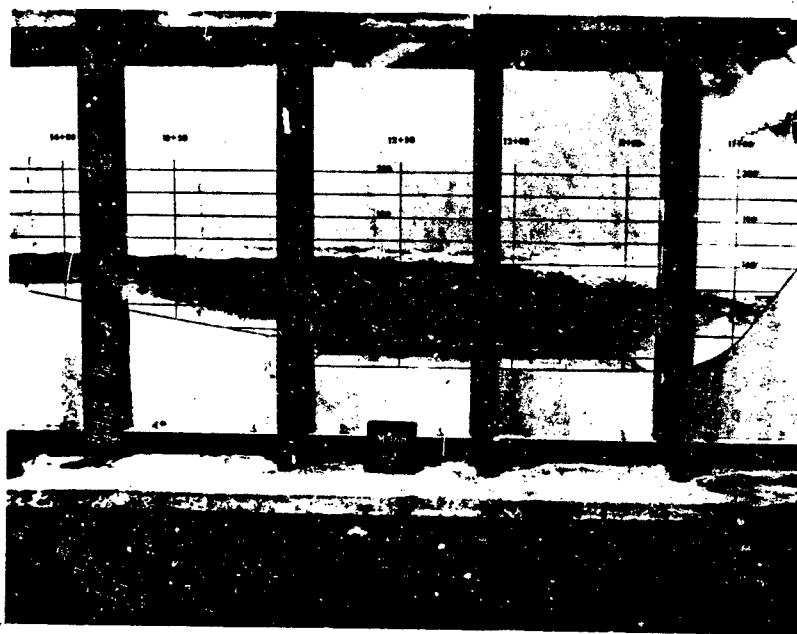
Downstream topography at elevation 115.

Downstream topography at elevation 145.

Photograph 26. Flow conditions with 12.5-foot deflectors at elevation 149. Spillway discharge 3,000 cfs per bay. River discharge 250,000 cfs. Pool elevation 265; tailwater elevation 163.0. 9 powerhouse units in operation.

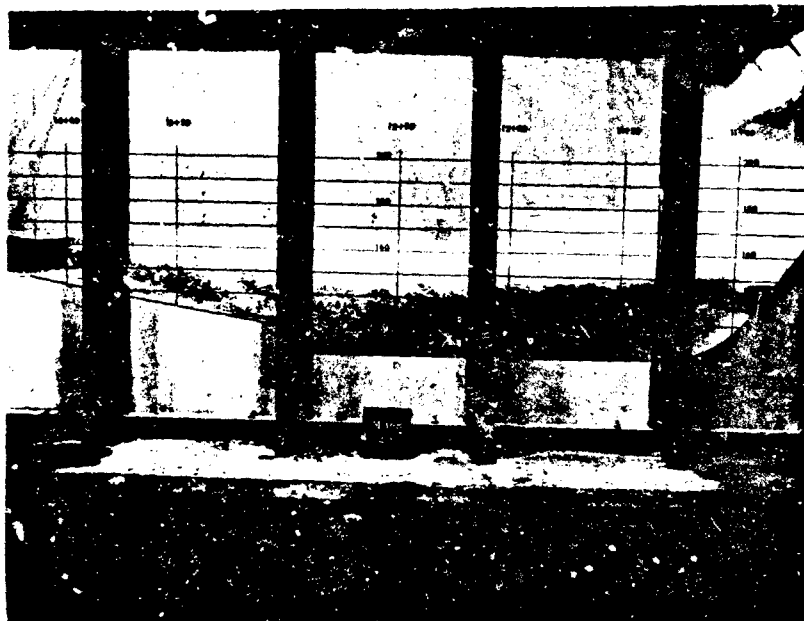
Downstream topography at elevation 115.

Downstream topography at elevation 145.

Photograph 27. Flow conditions with 12.5-foot deflectors at elevation 149. Spillway discharge 7,200 cfs per bay. River discharge 250,000 cfs. Pool elevation 265; tailwater elevation 163.0. 5 powerhouse units in operation.

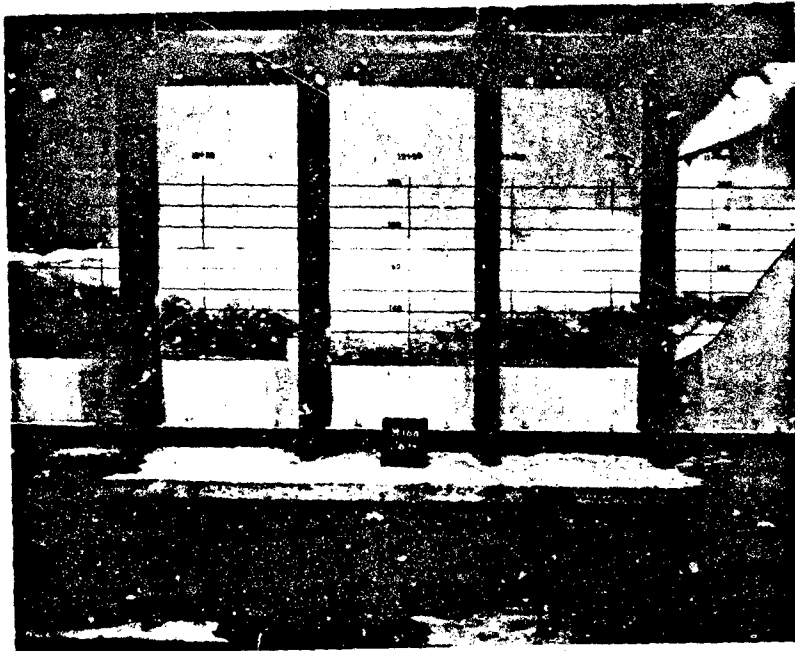
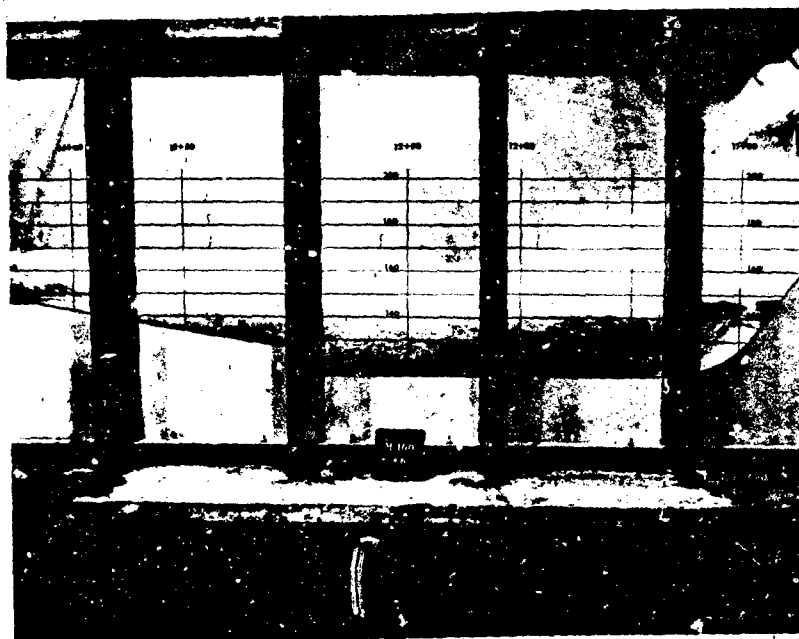
Downstream topography at elevation 115.

Downstream topography at elevation 145.

Photograph 28. Flow conditions with 12.5-foot deflectors at elevation 149. Spillway discharge 12,000 cfs per bay. River discharge 350,000 cfs. Pool elevation 265; tailwater elevation 165.3. 5 powerhouse units in operation.

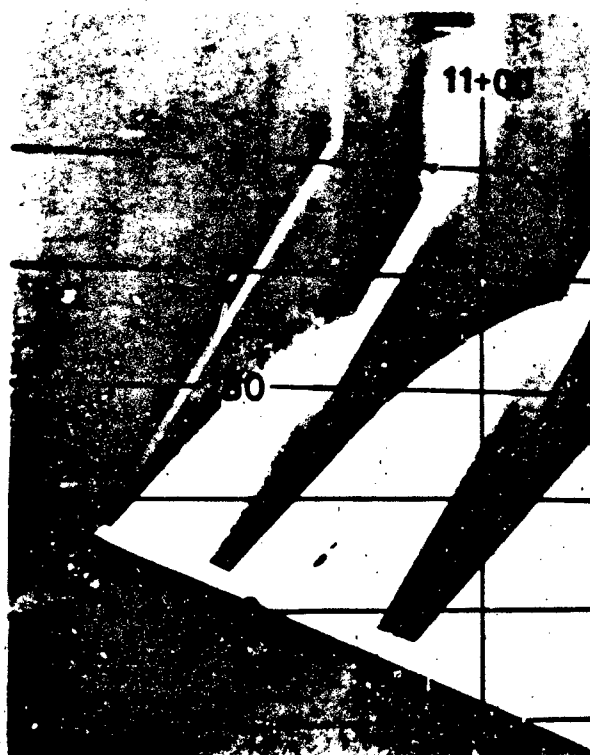
McNary Dam

Photograph 30. Existing spillway and stilling basin in
1:40-scale sectional model.

23. A 1:40-scale three-bay sectional model of the spillway, stilling basin, and a portion of the downstream channel (photograph 30 and plate 23) was used to establish the deflector geometry. The spillway crest and toe curve were constructed of sheet metal that was attached to plywood ribs. The upstream faces and ends of the gates and the test deflectors were made of acrylic plastic; other elements of the model were constructed of waterproofed wood and plywood. Pool elevation 340.0 was maintained by the spillway gates (except during free flow with the project design discharge of 2,200,000 cfs at pool elevation 356.5). Tailwater elevations (plate 24) were controlled by a vaned tailgate and measured on the centerline of the model 1,000 feet downstream from the crest axis.

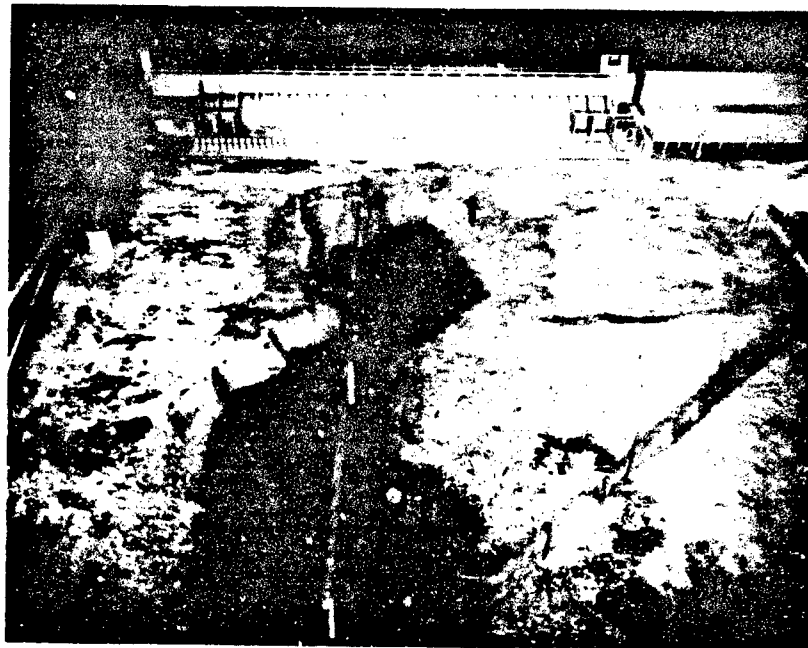
McNary Dam

Photograph 31. Existing structures in 1:50-scale comprehensive model.

24. The 1:50-scale comprehensive model (photograph 31 and plate 25) was used to determine the effects of the recommended deflector on flow conditions and to establish spillway operation schedules for

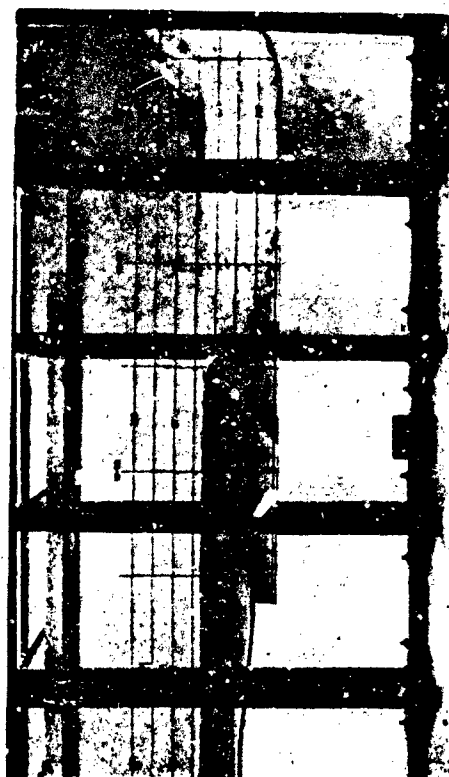
McNary Dam

Tailwater elevation 266.9.
John Day pool elevation 257.

Tailwater elevation 270.5.
John Day pool elevation 265.

Flow under gates.

Flow between gate sections.

Photograph 32. Flow conditions with existing spillway and stilling basin; spillway discharge 6,000 cfs per bay (river discharge 350,000 cfs).

26. Flow conditions of varied spillway discharges with flow under the gates and between the top and bottom gate leaves are shown in photographs 32 through 36 and on plates 26 through 32. With all discharges and spillway gate conditions, aerated water plunged to the stilling basin floor and created conditions conducive for maximum nitrogen supersaturation of the flow leaving the basin. With all flow conditions tested, more spill was required through the end bays than through the center bays to create downstream flow adjacent to the fishway entrances (plates 33 through 35). As a result an eddy or very slow current existed downstream from the center bays. Flow near the Washington-shore fish ladder entrance was downstream with a small eddy along the ladder wall 150 to 200 feet downstream from the entrance. Maximum upstream velocities in the eddy increased from 1 to 2 fps at 300,000 cfs to 5 fps at 500,000 cfs. A good path of attraction flow toward the entrance existed along the right bank for all discharges. Flow from the spillway/powerhouse fishway entrance was affected by powerhouse discharge that moved diagonally across the end of the trash sluice and carried the attraction flow downstream in that area. An eddy existed along the north side of the trash sluice but did not interfere with fishway attraction flow since a flow path to the entrance existed with all river discharges. Fishway attraction flows were satisfactory with all tailwater conditions tested.

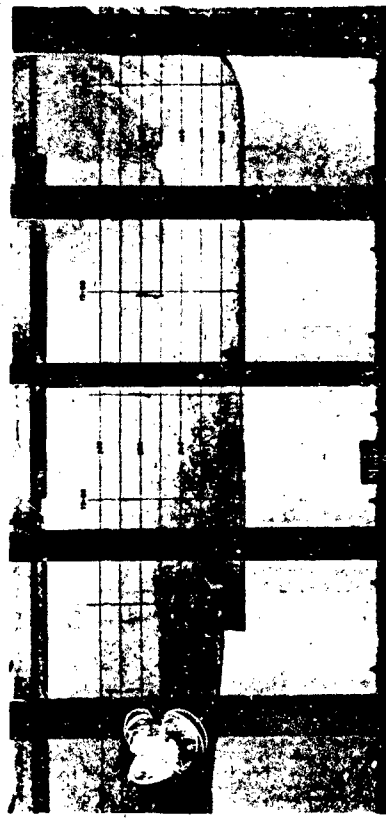
McNary Dam

Tailwater elevation 271.7.
John Day pool elevation 257.

Tailwater elevation 274.0.
John Day pool elevation 265.

Flow under gates.

Flow between gate sections.

Photograph 34. Flow conditions with existing spillway and stilling basin; spillway discharge 13,500 cfs per bay (river discharge 500,000 cfs).

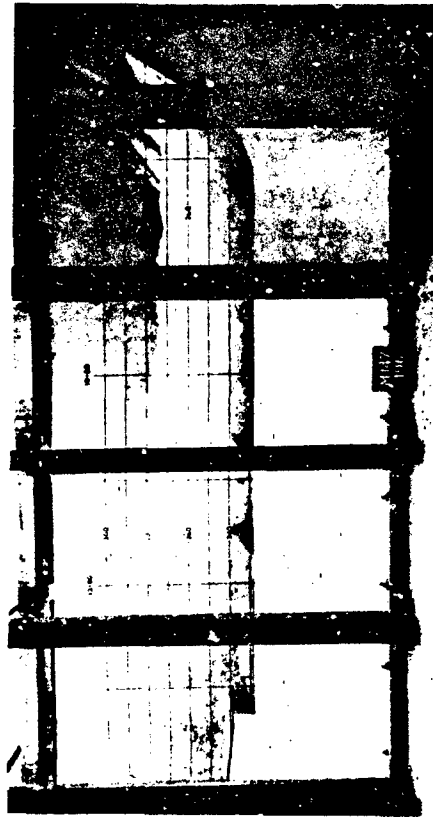
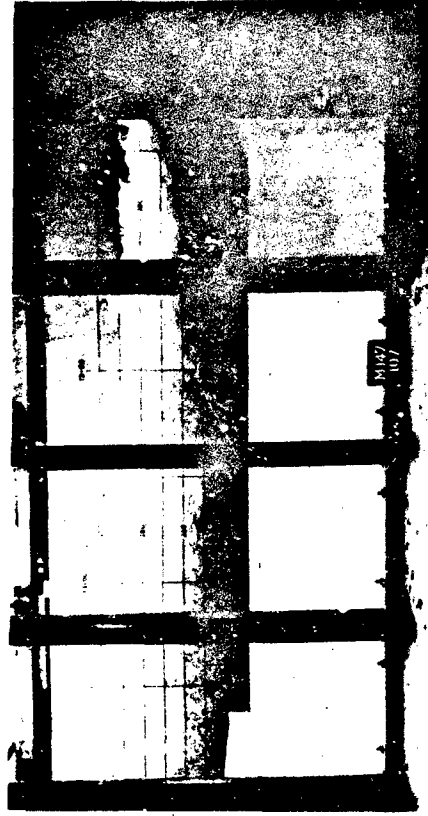
McNary Dam

Spillway discharge 28,500 cfs per bay. River discharge 800,000 cfs. Tailwater elevation 281.0. John Day pool elevation 268. Flow under gates.

Spillway discharge 100,000 cfs per bay. River discharge 2,200,000 cfs. Tailwater elevation 302.6. Free flow.

Photograph 36. Flow conditions with existing spillway and stilling basin.

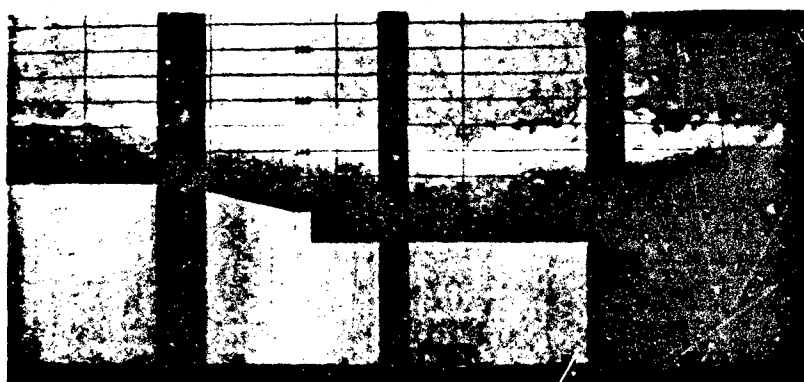
River discharge 160,000 cfs, spillway flow 6,500 cfs per bay, tailwater elevation 350.0, 8-bay operation.

River discharge 210,000 cfs, spillway flow 12,500 cfs per bay, tailwater elevation 352.6, 8-bay operation.

River discharge 250,000 cfs, spillway flow 17,500 cfs per bay, tailwater elevation 354.6, 8-bay operation.

Photograph 45. Flow conditions in stilling basin with 12.5-foot deflectors at elevation 336.0.

41. Flow conditions and zones of aeration in the stilling basin with the deflectors at the recommended elevation of 336 and discharges of 6,500 through 17,500 cfs per bay are shown on photograph 45 and plate 56. Photograph 46 shows that energy dissipation in the stilling basin was satisfactory with the deflectors at elevation 336 during the standard project flood of 420,000 cfs and the project design discharge of 850,000 cfs.

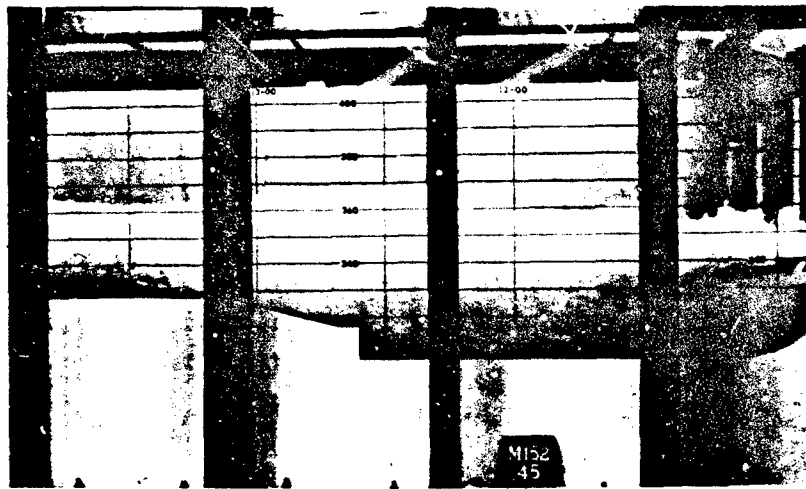
River discharge 420,000 cfs, spillway flow 39,000 cfs per bay, tailwater elevation 363.0, 8-bay operation.

River discharge 850,000 cfs, spillway flow 85,000 cfs per bay, tailwater elevation 373.8, 10-bay operation.

Photograph 46. Flow conditions in stilling basin with 12.5-foot deflector at elevation 336.0.

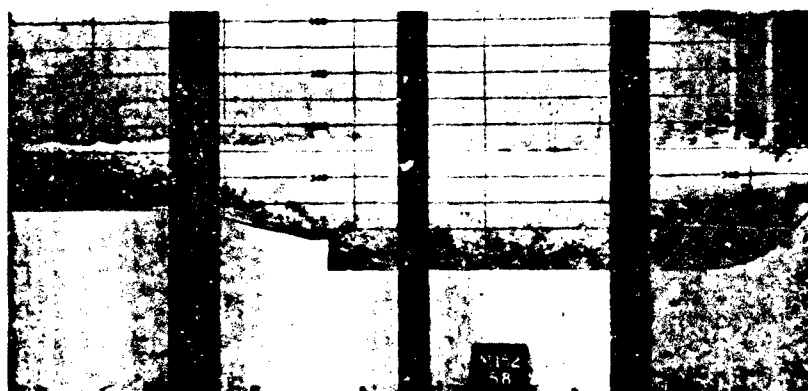
River discharge 160,000 cfs, spillway flow 6,500 cfs per bay, tailwater elevation 350.0.

River discharge 210,000 cfs, spillway flow 12,500 cfs per bay, tailwater elevation 352.6.

River discharge 250,000 cfs, spillway flow 17,500 cfs per bay, tailwater elevation 354.6.

Photograph 47. Flow conditions in stilling basin with 12.5-foot deflectors at elevation 336.0, plan A dentates, and 8-bay operation.

43. Two arrangements of dentates were tested with the 12.5-foot deflectors at elevation 336 (plate 53). The depth and quantity of aeration in the stilling basin for dentate Plan A (two rows) and Plan B (three rows) are shown in photographs 47 and 48, respectively. Both plans reduced aeration during the 2-year flood; however, little improvement occurred during the 5-year flood and the dentates were not beneficial at the 10-year discharge. Since the ability of dentates to withstand cavitation damage and debris impact is questionable and their effect on fish passing downstream over the spillway was unknown, they were not recommended for use.

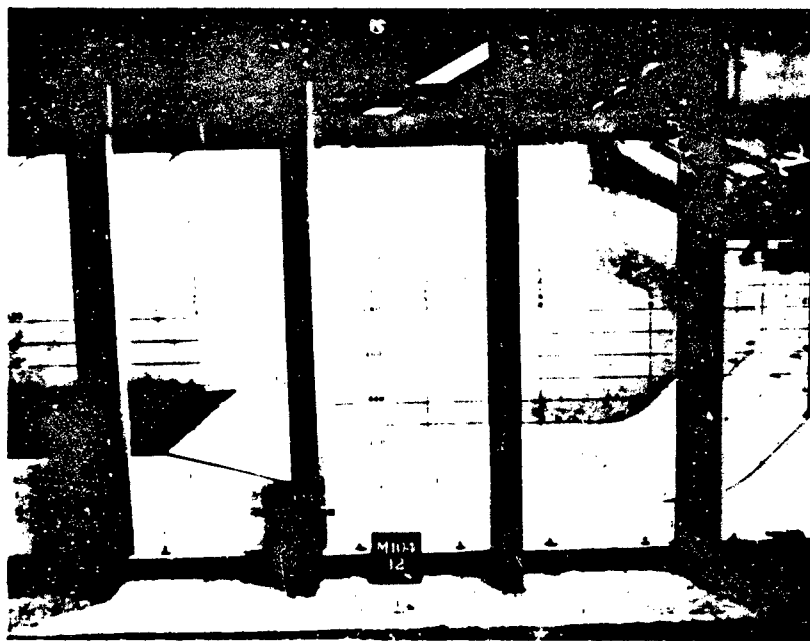
Photograph 49. Existing spillway and stilling basin in
1:42.47-scale model.

46. A 1:42.47-scale model (photograph 49 and plate 60) was used to develop the deflector design. The model was a reproduction of a three-bay section of the spillway with approximately 1,000 feet of upstream approach, the stilling basin, and 1,400 feet of the downstream channel at elevation 418. The spillway crest, piers, gates, and bucket were constructed of acrylic plastic, while the stilling basin and upstream and downstream channels were constructed of wood. The pool elevation was controlled by the spillway gates, and the computed tailwater elevations (plate 61) were controlled by a vaned tailgate.

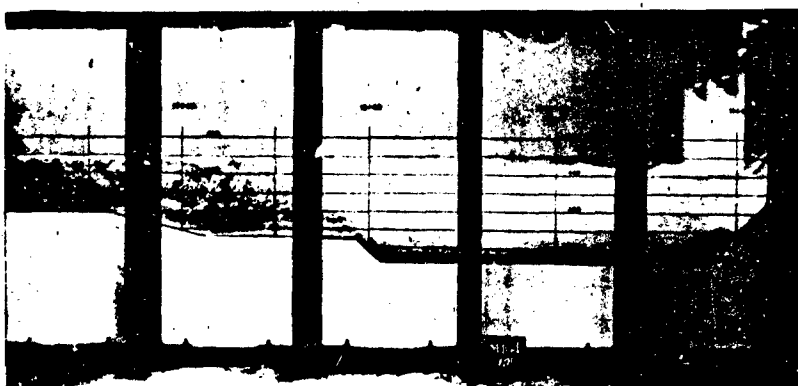
River flow 172,000 cfs (5,175 cfs per bay),
tailwater elevation 445.1.

River flow 212,000 cfs (10,060 cfs per bay),
tailwater elevation 447.2.

River flow 251,000 cfs (15,000 cfs per bay),
tailwater elevation 449.0.

Photograph 51. Flow conditions in existing stilling basin.

48. Spillway flows of 5,175, 10,060, and 15,000 cfs per bay--which correspond to river discharges of 172,000, 212,000 and 251,000 cfs, respectively,--were observed with the existing (without deflectors) spillway for comparison with conditions after the deflectors were installed. The air-bubble pattern in the basin (plate 63 and photograph 51) indicated that aerated water penetrated to the basin floor and then was distributed throughout the basin and carried downstream.

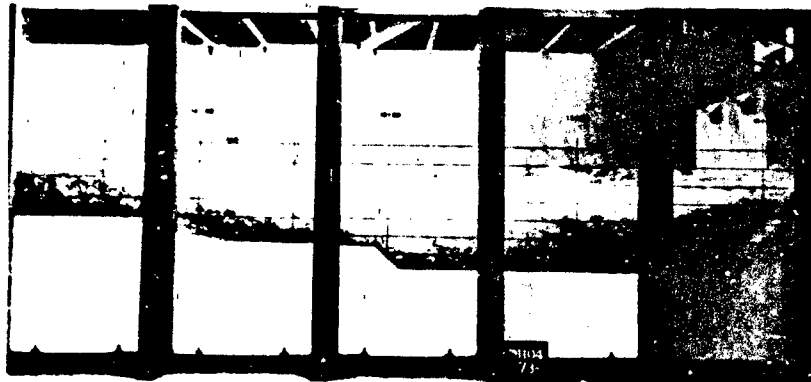
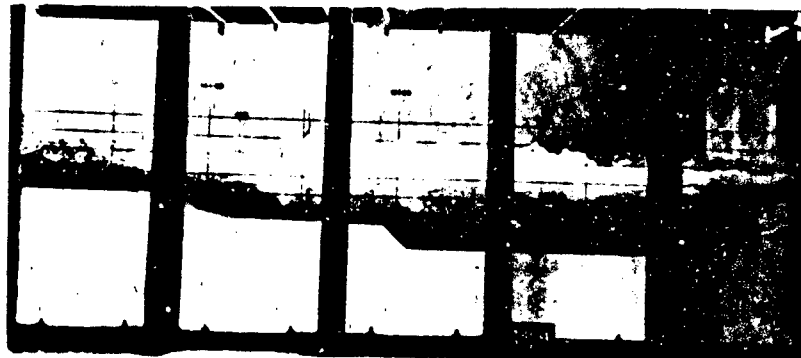
River flow 172,000 cfs (5,175 cfs per bay),
tailwater elevation 445.1.

River flow 212,000 cfs (10,060 cfs per bay),
tailwater elevation 447.2.

River flow 251,000 cfs (15,000 cfs per bay),
tailwater elevation 449.0.

Photograph 53. Flow conditions in stilling basin with
15-foot deflectors at elevation 438.0.

50. Varying the deflector length from 15.0 to 12.5 feet had little effect on its ability to produce skimming flow and reduce the amount of air drawn to the basin floor. Photographs 53 through 56 and photographs 57 through 59 show flow conditions in the stilling basin with 15.0- and 12.5-foot-long deflectors, respectively, for various discharges and deflector locations. The extent of aeration was very similar with the two deflector lengths; however, conditions with the 12.5-foot-long deflector were slightly better at the higher (15,000 cfs per bay) discharge. Both deflector lengths were ineffective with

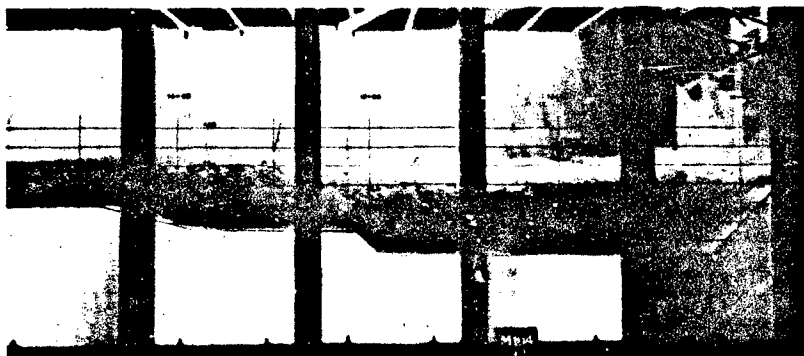
River flow 172,000 cfs (5,175 cfs per bay),
tailwater elevation 445.1.

River flow 212,000 cfs (10,060 cfs per bay),
tailwater elevation 447.2.

River flow 251,000 cfs (15,000 cfs per bay),
tailwater elevation 449.0.

Photograph 57. Flow conditions in stilling basin with
12.5-foot deflectors at elevation 438.0.

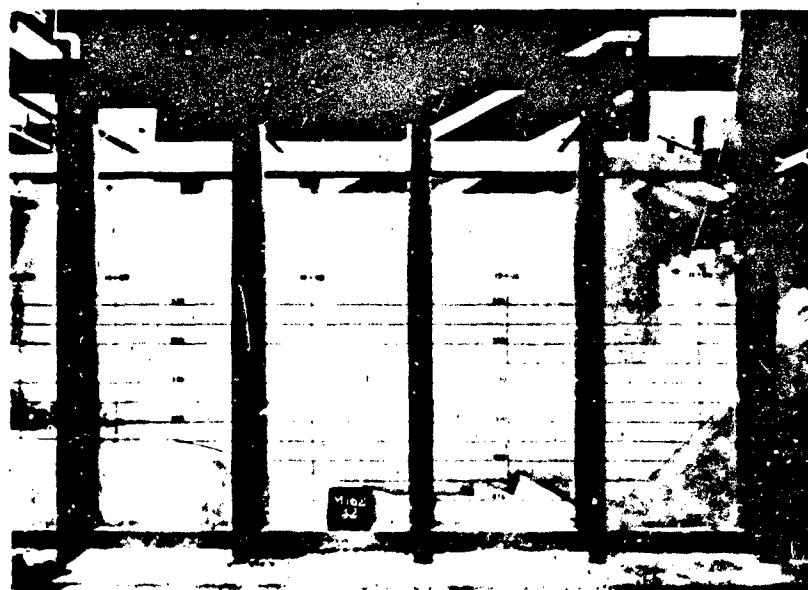
Discharge 22,700 cfs per bay. River flow 251,000 cfs.
Tailwater elevation 544.0.

Discharge 34,200 cfs per bay. River flow 344,000 cfs.
Tailwater elevation 546.4.

Photograph 76. Flow conditions with existing spillway
and roller bucket (no deflector).

65. Tests were accomplished in both models for conditions both with and without deflectors. River discharges between 160,000 and 850,000 cfs (4,700 and 106,250 cfs per bay) were tested in the sectional model, and discharges between 100,000 and 506,400 cfs were tested in the comprehensive model. Without the deflectors, large volumes of aerated water were carried to the bottom of the bucket with all discharges tested. Such conditions would create nitrogen supersaturation in the water downstream of the project. Flow conditions without the deflector are shown on plates 93 and 94 and photographs 75 through 77. Velocities measured just downstream of the bucket apron are listed in table E.

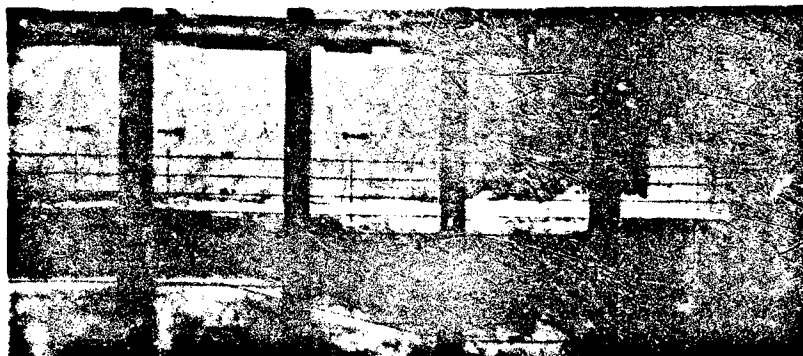
Discharge 4,700 cfs per bay. River flow 172,000 cfs.
Tailwater elevation 542.4.

Discharge 11,650 cfs per bay. River flow 160,000 cfs.
Tailwater elevation 541.9.

Discharge 18,000 cfs per bay. River flow 212,000 cfs.
Tailwater elevation 543.2.

Photograph 78. Flow conditions with 8-foot deflector at
elevation 532 (final design).

66. Four different deflector lengths--8.0, 10.0, 12.5 and 17.5 feet--were initially tested in the sectional model (plate 95). The two longer deflectors were unacceptable since flow at high discharges overshot the dentates and impacted directly on the unpaved tailwater channel downstream of the roller bucket. The optimum deflector elevation was determined by varying the 10-foot-long deflector between elevations 528 and 532. The deflector located at elevation 532 produced the greatest range of stable, skimming flow--the most desirable condition for preventing supersaturation (plate 96). The 8.0-foot-long deflector was tested at elevation 532 and provided more stability at the higher discharges and was therefore selected as the final design. Flow conditions with the final-design deflector are shown on plates 97 and 98 and photographs 78 through 80. Velocities at the end of the roller bucket runout are listed on table E.

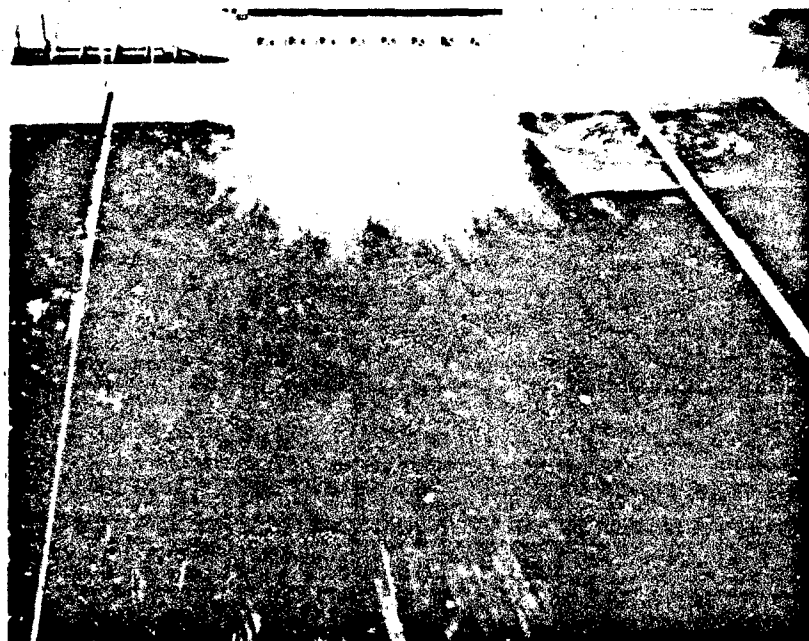
Photograph 85. Flow conditions without deflectors.
River discharge 506,400 cfs; powerhouse
not operating.

uniform for all eight bays as the total spill would allow. Later tests were made with non-uniform spill to improve fish passage conditions. Flow from the north shore fishway was carried into the spillway flow rather quickly with the lower discharges; but as the spillway flow increased, the attraction flow was carried farther downstream. The expanding spillway flow caused the eddy along the fill to become tighter with higher velocities at the 420,000-cfs flow. Conditions around the fishway entrance at unit 6 were satisfactory at all flows. The energy dissipation created with uniform spill was well distributed across the spillway and provided good downstream flow conditions along both banks. Flow conditions existing without the deflectors are shown on plates 100 through 107 and in photographs 81 through 85.
